Project Introduction

Washington County

ST. CROIX BLUFFS REGIONAL PARK RAVINE STABILIZATION – PHASE 1

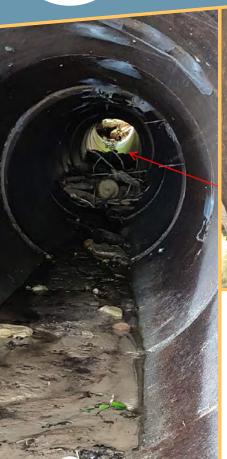
Left: Grade break in pipe causing debris buildup

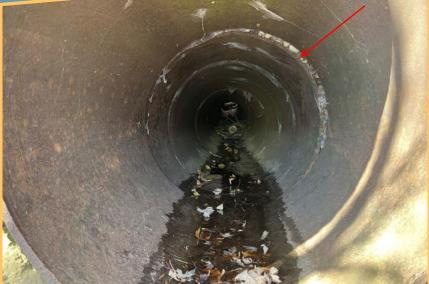
Above: Offset pipe joints visible from downstream

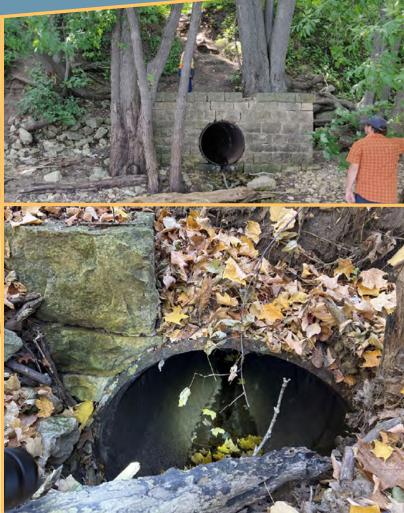
Bottom Right: Pipe inlet blocked with debris;

block wall either missing or gone

- Native slope restoration on western embankment
- Vegetated riprap restoration on eastern embankment
- Remove western portion of 36" steel culvert
- Install new manhole drop structure with emergency overflow to match existing downstream culvert grade
- Install new 30" HDPE culvert from new manhole through remaining existing pipe to outlet
- Regrading of trail alignment to correct/improve slopes
